# Assessment of Effects on the Environment Pursuant to Schedule 4 of the Resource Management Act

Application by PH Redwood and Co Ltd for resource consent to renew and extend Marine Farm 440 and 441 in Pigeon Bay, Forsyth Island.

1.0	Intro	duction	4
2.0	Back	ground information	5
2.1	Stu	ıdy area	-
2.2		storical reports	
3.0	Meth	nods (present survey)	9
3.1	Soi	nar imaging	9
3.2	Dr	op camera stations, depths and low tide	9
4.0	Pocul	lts	11
4.0			
4.1	Co	nsent corners and surface structures	11
4.2	Sor	nar imaging	14
4.3	Dro	op camera images	17
5.0	Conc	lusions	23
5.1	Bei	nthic habitats	23
5.2		ecies and communities	
5.3	-	ussel farming impacts	
5	.3.1	Benthic impacts	24
5	.3.2	Productivity	24
5.4	Во	undary adjustments, recommendations and monitoring	25
Refere	ences .		26
Apper	ndix 1.	Drop camera photographs	27

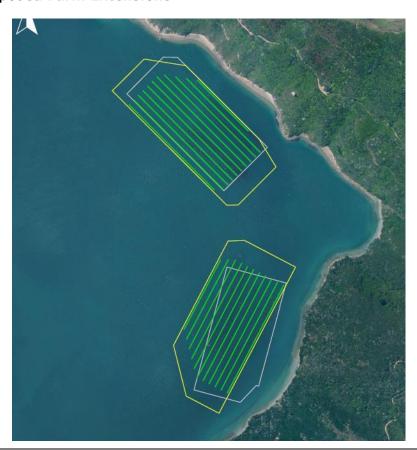
**Figure 2 Proposed Farm Extensions**

Key: white outline, extent of existing farm Yellow outline; extent of proposed extension Green lines, location of lines

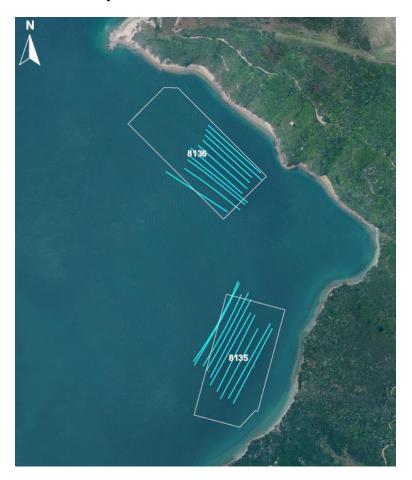
Figure 6 - Current Farm Layout

Figure 6 below illustrates the current scale and layout of the farm, showing the position of the lines relative to the existing consented farm boundaries. This shows some of the lines extend partially outside the consented boundaries and portions of the consented

farms have not been utilised. These matters will be corrected by this application and the lines being proposed to be moved and realigned to be within the consented farm area.

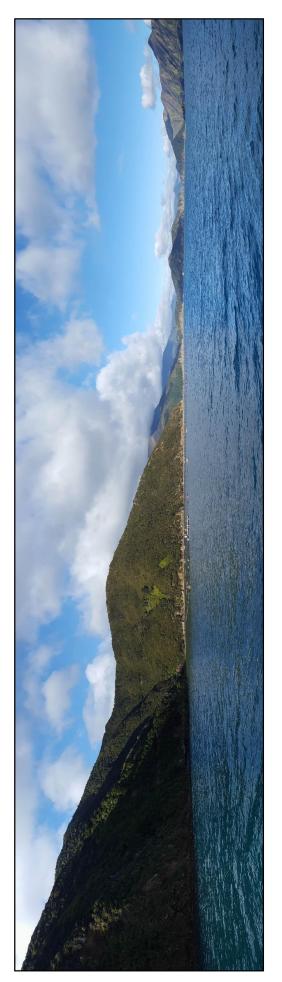
Plate 1. Looking southeast towards the existing lines of northern farm site 8136. Photo taken offshore of northern headland of Pigeon Bay.

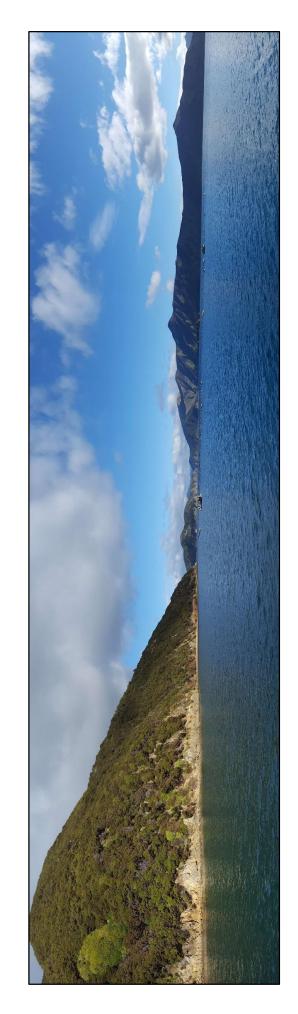
Plate 2. Looking southward to the existing lines of southern farm site 8135. Photo taken offshore in central Pigeon Bay.

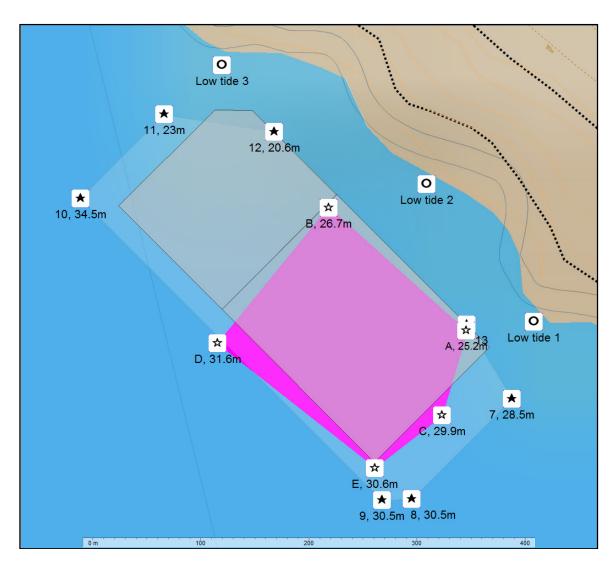
Figure 3a. Depths of site 8136 proposed relicense with extension (pale blue) and original consent boundaries (grey) of the northern block. Marine farm surface structures shown in pink.

The existing surface structures of 8136 consisted of one block of backbones covering 3 ha of the 5 ha consent.

The distance between low tide and the proposed inshore consent boundary was measured at three locations along the adjacent shoreline. The distance to the inshore boundary at the position of low tide 1 was 55 m, distance of 65 m at low tide 2, and distance of 53 m at low tide 3.

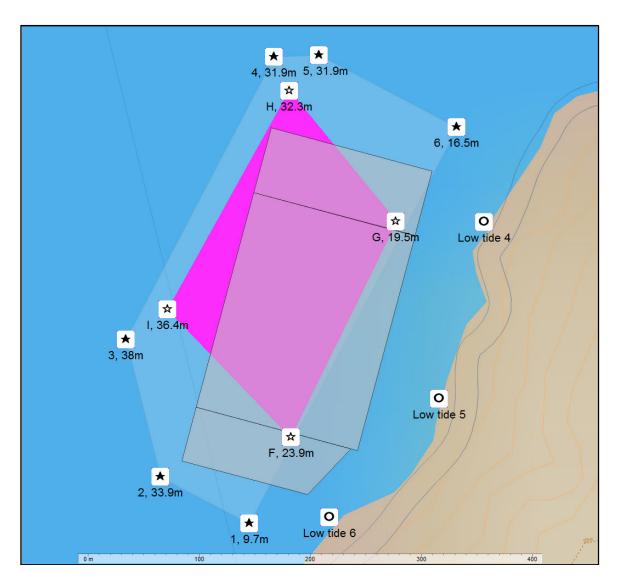
Figure 3b. Depths of site 8135 proposed relicense with extension (pale blue) and original consent boundaries (grey) of the southern block. Marine farm surface structures shown in pink.

The existing surface structures of 8135 consisted of one block of backbones covering 3.2 ha of the 4.55 ha consent.

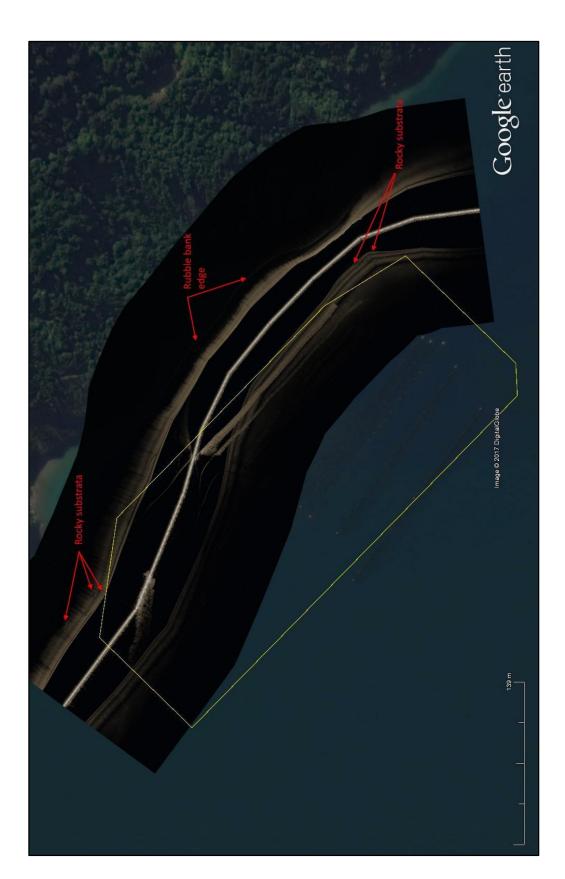
The sonar transect along the inshore proposed boundary of site 8136 revealed the area was relatively flat, with a featureless seafloor under the consent. Backbone structures and warps were recorded within the consent. A cobble bank was recorded inshore of the consent boundary (Figure 4a). Cobble material mixed with soft substrata extended further from the defined rubble bank into the consent along part of the northwest inshore boundary.

Sonar transects at site 8135 along the inshore proposed boundary and across the southern proposed extension area revealed the area was relatively flat, with a featureless seafloor under the consent. Some anchors blocks were defined by sonar within the consent area. A cobble bank was recorded well inshore of the consent boundary (Figure 4b). A bedrock reef was recorded south of the proposed consent area, with occasional boulders and cobbles present towards the consent area from this reef.

Figure 4a. Sonar transect at farm 8316. Yellow polygon = proposed new consent boundary including the extension, white line = sonar track.

Figure 4b. Sonar transects at farm 8315. Yellow polygon = proposed new consent boundary including the extension, white line = sonar track.

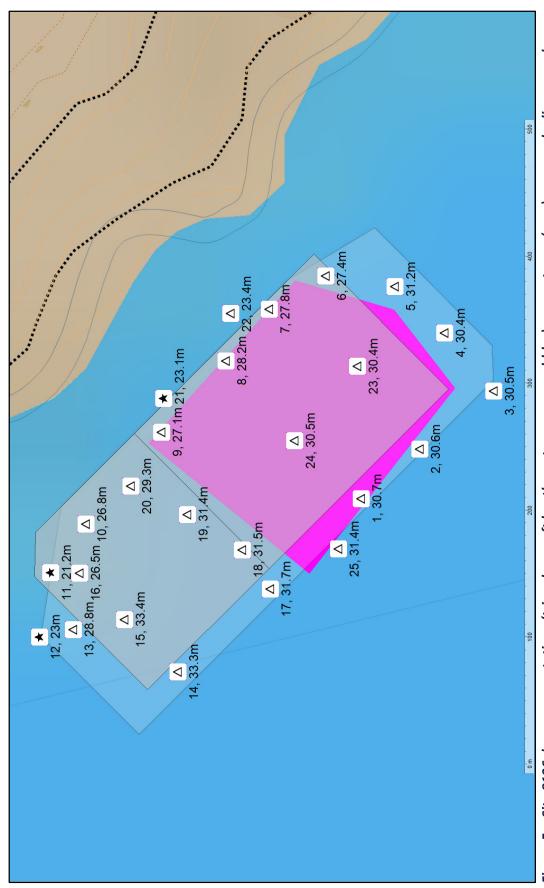
Figure 5a. Site 8136 drop camera stations (triangles = soft benthos, stars = some cobbles), consent area (grey), proposed relicense and extension (pale blue), and surface structures (pink). Numbers are photo number and water depth (m).

At 8136 occasional cobbles were recorded to the proposed inshore boundary (Figure 5a, Plate 3). No other cobble, boulder or bedrock habitat was observed within 8136 proposed relicense site and extension. At 8135 cobbles were recorded at the northeast and southeast corners of the proposed relicensing and extension area. No mussel shell debris was observed on these cobble habitats at these areas were mostly located where anchors and warps are located (Figures 5a and 5b, Plate 4).

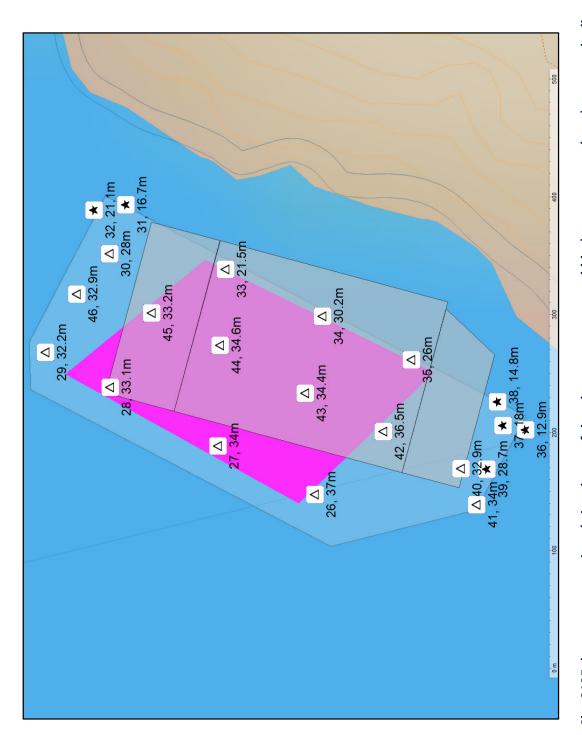
Figure 5b. Site 8135 drop camera stations (triangles = soft benthos, stars = some cobbles), consent area (grey), proposed relicense and extension (pale blue), and surface structures (pink). Numbers are photo number and water depth (m).

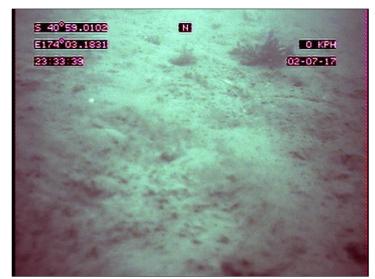
Plate 5. Silt and clay in 8136 (photo 4, 30.4 m depth).

The benthos under sites 8135 and 8136 was dominated by silt and clay substratum (Table 2, Plate 5). Very little natural shell was observed from within the consents (Plate 6, Table 2)

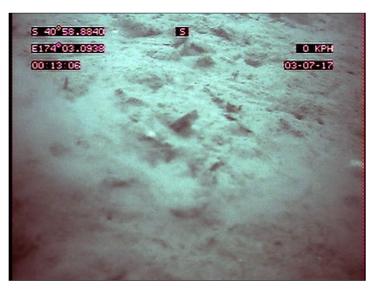
Plate 6. Silt and clay with natural shell (photo 20, 29.3 m depth).

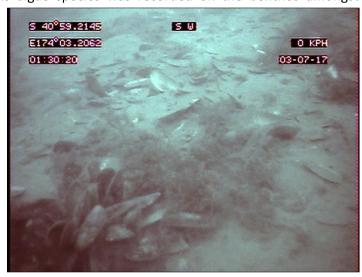
Plate 8. Silt and clay with mussel shell debris and filamentous algae (photo 34, 30.2 m depth).

Filamentous algae was observed on the benthos within the consent areas, inshore and alongshore, and under existing backbone structures. No "algal bed" was documented as percentage covers were low. This algae species was recorded on the benthos amongst

mussel shell debris and also areas without mussel shell debris (e.g. Plate 4).
